# Manhole Inspection Summary

Manhole # S29YY\_017MH

Insp Date: **5/22/07 12:20 PM**

**Location** Address: **500 33RD ST**

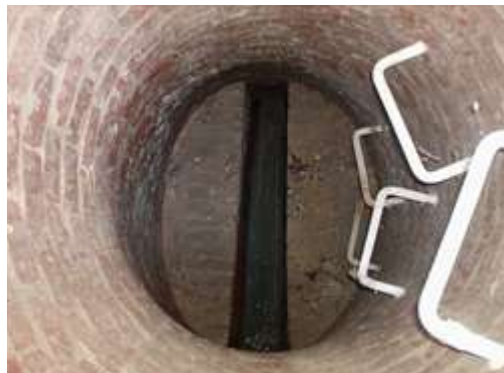
Top View

**Bench** ☒ Exists Material: **Brick** ☐ Parged ☒ **Debris** (not Condition related)

Bench debris.

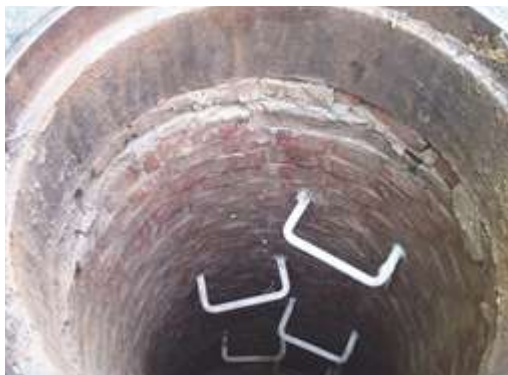
Defect

**Frame** Offset: **0** (in.) Condition: ☐ Sound ☐ Cracked ☒ **Leaks**

Condition: ☐ Sound ☐ Cracked ☐ Root Intrusion ☒ **Loose Brick** ☒ **Deteriorated**

Infiltration: ☐ None ☒ **Joint** ☐ Cracks ☐ Mortar ☐ Roots ☒ **Wall**

Infiltration: ☐ None ☐ Joint ☐ Cracks ☒ **Mortar** ☐ Roots ☒ **Wall**

Frame leaks. Adjustment deterioration, loose brick and infiltration. Barrel infiltration - other side.

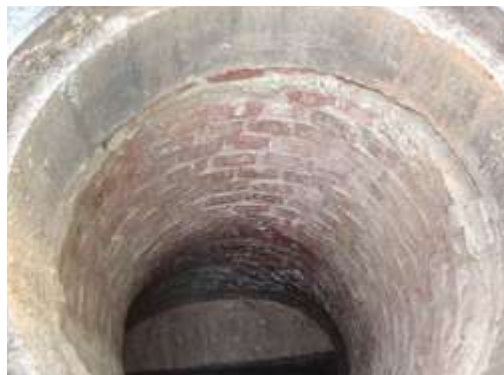
Defect

Frame leaks. Adjustment deterioration, loose brick and infiltration. Barrel infiltration.

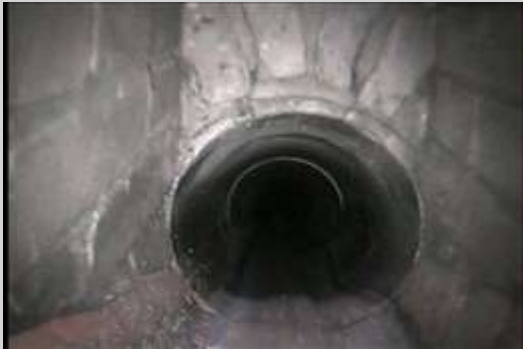
### 8 in. Circular Gravity Sewer Pipe Out @ 12 O'Clock

Infiltration: **Evidence** Pipe Seal Cond: **Cracked**

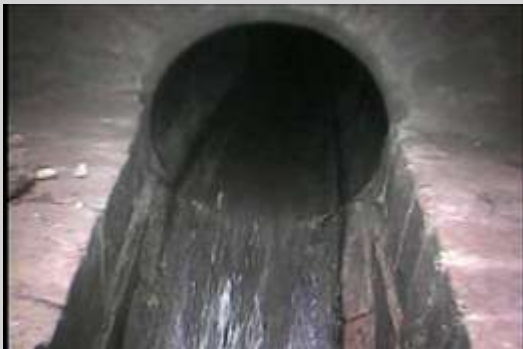
### 8 in. Circular Gravity Sewer Pipe In @ 6 O'Clock

Infiltration: **Evidence** Pipe Seal Cond: **Unknown**
